## Providing Mechanical Support for Tank Cleaning Contractors

## Providing Mechanical Support for Tank Cleaning Contractors - Case Study 1

## Providing Mechanical Support for Tank Cleaning Contractors - Case Study 2

## Providing Mechanical Support for Tank Cleaning Contractors - Case Study 3

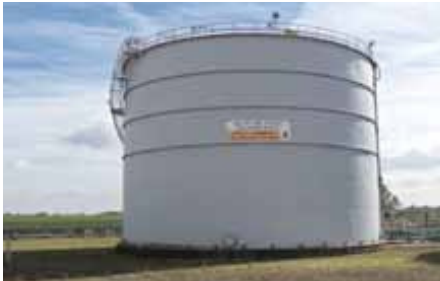
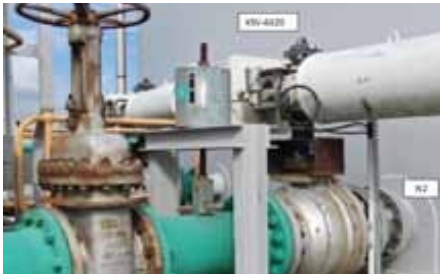
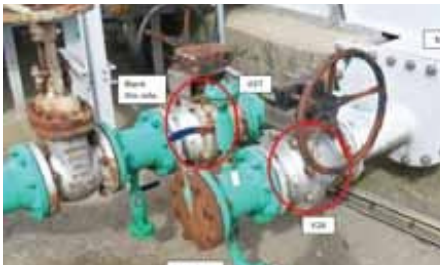
- ① The removal of isolation valves and control valves ranging from 6"-12"
- ① Removal of 8" import lines and blanking off all open ends ranging from 2" -12"
- ① Installation of blanks and slip blinds ranging from 2" -12"
- ① Removal of 24" roof manways and other tank roof nozzles
- ① Removal of 30" Shell side manways for tank entry

All line works were carried out using breathing apparatus.

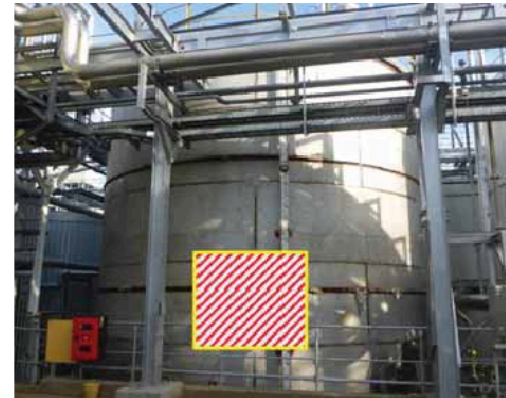
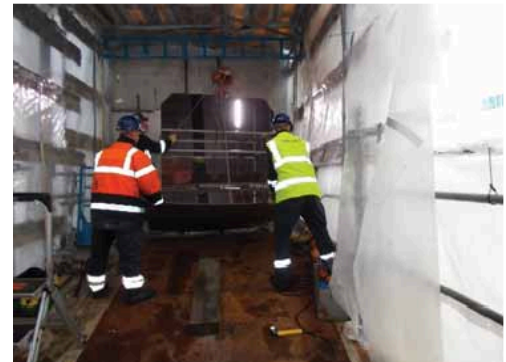
Pre-fabrication and installation of structural ramps and anti slip plates for forklift access Facilitating the cold cutting of the access door and removing it from the shell hole for scrap

Supply and welding of replacement rolled stainless steel shell plate into access hole Carrying out emergent repairs to the tank shell following tank remediation Supply and Coordinating of NDT including shell seams X-ray following welding Removal of all structural steel & assisting with full demobilization to allow the tank to return to operability

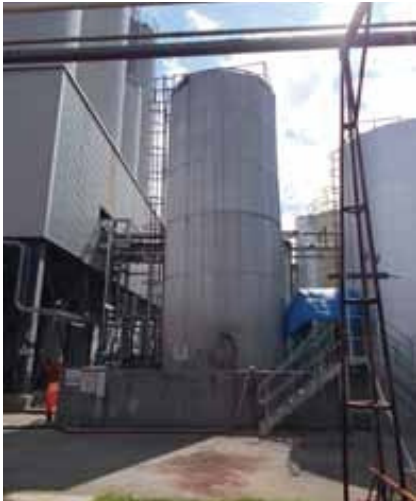
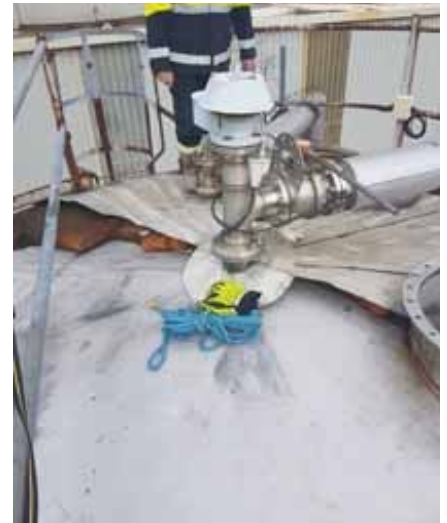
A Teeside based Waste Management and Remediation Company had been awarded a contract to remove solidified Formaldehyde from a Stainless Steel Storage Tank at a timber processing facility in Stirling. Over time the product had settled in the tank and solidified to such an extent that the tank shell had serious buckling and structural damage rendering it totally inoperable for future use. After the product had been removed the tank was to be demolished and removed from site. Once the product had been removed the tank was to be demolished due to its poor state. The facility owner placed the full responsibility of the tank demolition and initial tank isolation with the waste remediation company as part of their contract. As the demolition was not something the waste remediation company had the expertise in (or the resources), Unit Engineers & Constructors Ltd (UECL) were invited to support them with their project.

had to be solved by UECL. The lower section of the tank shell had peeled away from the sub frame that supported the tank and there was a risk of this peeling completely when the tank was lifted. Another problem would be the amount of windows that were to be cut from the tank shell for cleaning access, there was a risk of the tank buckling once top and tailed onto the trailer plus a question of structural integrity of tank during cleaning. UECL provided the solutions for these hurdles following discussions and the issue of calculations and detailed method statements. The remediation company submitted the RAMS and design proposals to the facility operator for approval. At the remedial company's request UECL mobilised a squad of skilled and experienced mechanical resources, to safely and efficiently carry out:

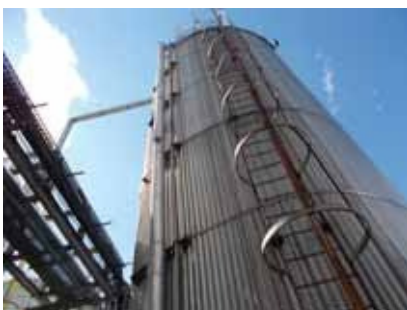
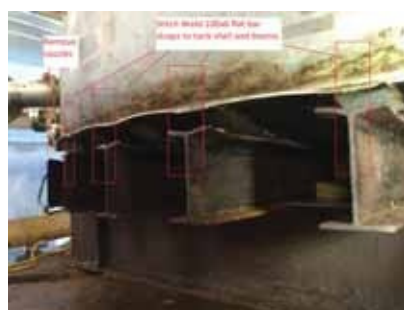
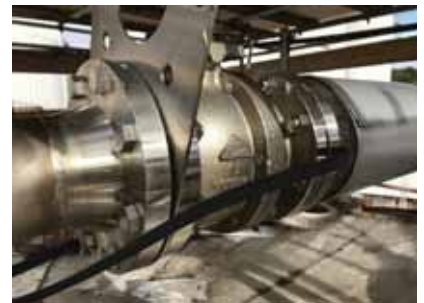
- ① Supply of MEWP and crane to remove ancillary items from the tank—caged ladder, existing pipework
- ① Isolate tank from 4" import lines

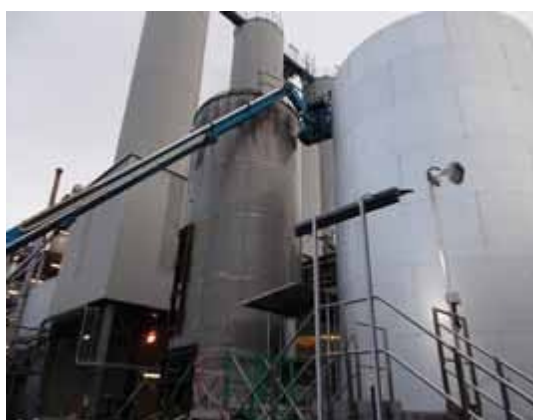
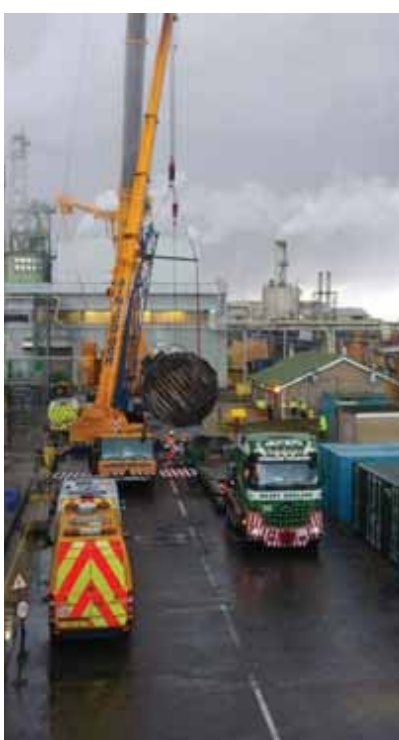
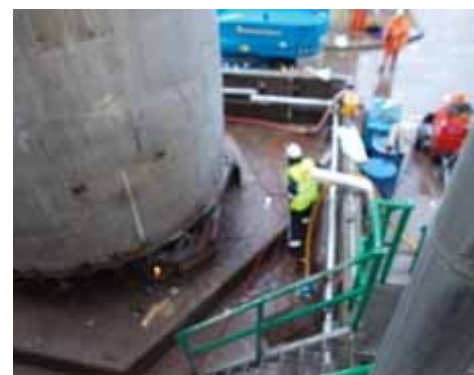
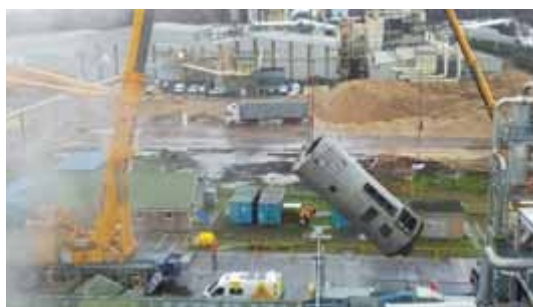
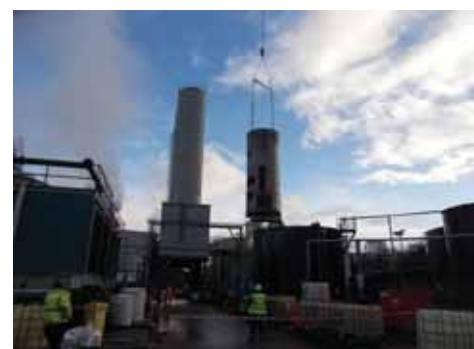
- ① Supply and welding of straps for tie-ing the subframe back to the tank—to prevent it peeling from the tank when lifted
- ① Supplying and welding of bracing around the access windows that had been cut into the tank—to prevent the tank buckling during top and tailing
- ① Mobilisation of 500 T crane supplied from the Heavy Lift Division of UECL's approved and trusted crane operator
- ① Lifting and removal of the tank from it's bund
- ① Final siting of crane onto waiting trailer and removal from site for demolition
- ① Removal of all structural steel and assisting with full demobilization

Throughout the 3 days it took to prepare and remove the tank from site there were minimal disruptions for the facility operator. This was major plus for the waste remediators' client who had originally anticipated 2 weeks of in situ demolition with potential disruptions from hotworks, cranes and vehicles.
